Manhole Inspection Summary

Manhole # S53Y1_001MH

Insp Date: **6/6/08 12:46 PM**

Location Address: **2402 Asiatic Ave.**

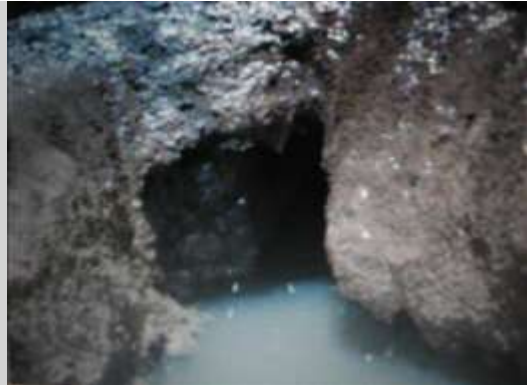
12 O'Clock Outflow

18 in. Circular Gravity Sewer
Pipe Out @ 12 O'Clock

Pipe Height: **18** (in.) Rod and Bar (Angled)
Pipe Material: **Unknown** ☐ Pipe Lined
Invert Depth: **17.80** (ft.) Flow Characteristics: **Slow**
Deposits: ☐ None ☐ Mud ☒ **Sludge** ☐ Debris ☐ Grease
Silt Depth: **8** (in.) Deposits Extent: **Heavy**
Infiltration: **Evidence** Pipe Seal Cond: **Sound**

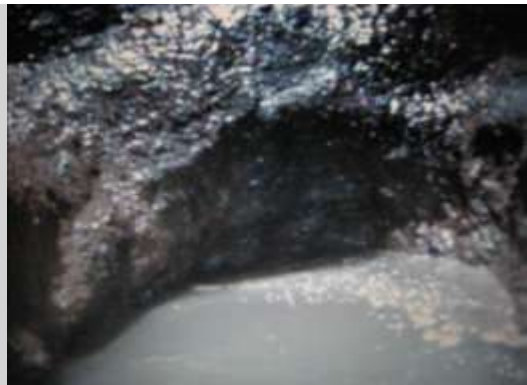
7 O'Clock Inflow

18 in. Circular Gravity Sewer
Pipe In @ 7 O'Clock

Pipe Height: **24** (in.) Rod and Bar (Angled)
Pipe Material: **Unknown** ☐ Pipe Lined
Invert Depth: **10.17** (ft.) Flow Characteristics: **Slow**
Deposits: ☐ None ☐ Mud ☒ **Sludge** ☐ Debris ☐ Grease
Silt Depth: **16** (in.) Deposits Extent: **Medium**
Infiltration: **Evidence** Pipe Seal Cond: **Sound**

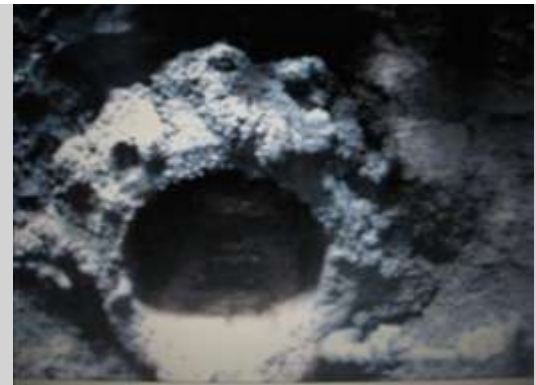
Drop In @ 7 O'Clock

Drop: **Outside** **Rod and Bar**
Angled: **Yes** Reading: **15.10** (ft.)
Inv Depth: **16.10** (ft.)
Drop Condition: **Open**
